RE: 301-309 MAIN ST., YARMOUTH, NS.

***STRUCTURAL REVIEW  
305 MAIN STREET  
YARMOUTH, NS***

***MARCH, 2015  
11815***

RE: ***305 Main Street / Structural Review  
Yarmouth, NS***

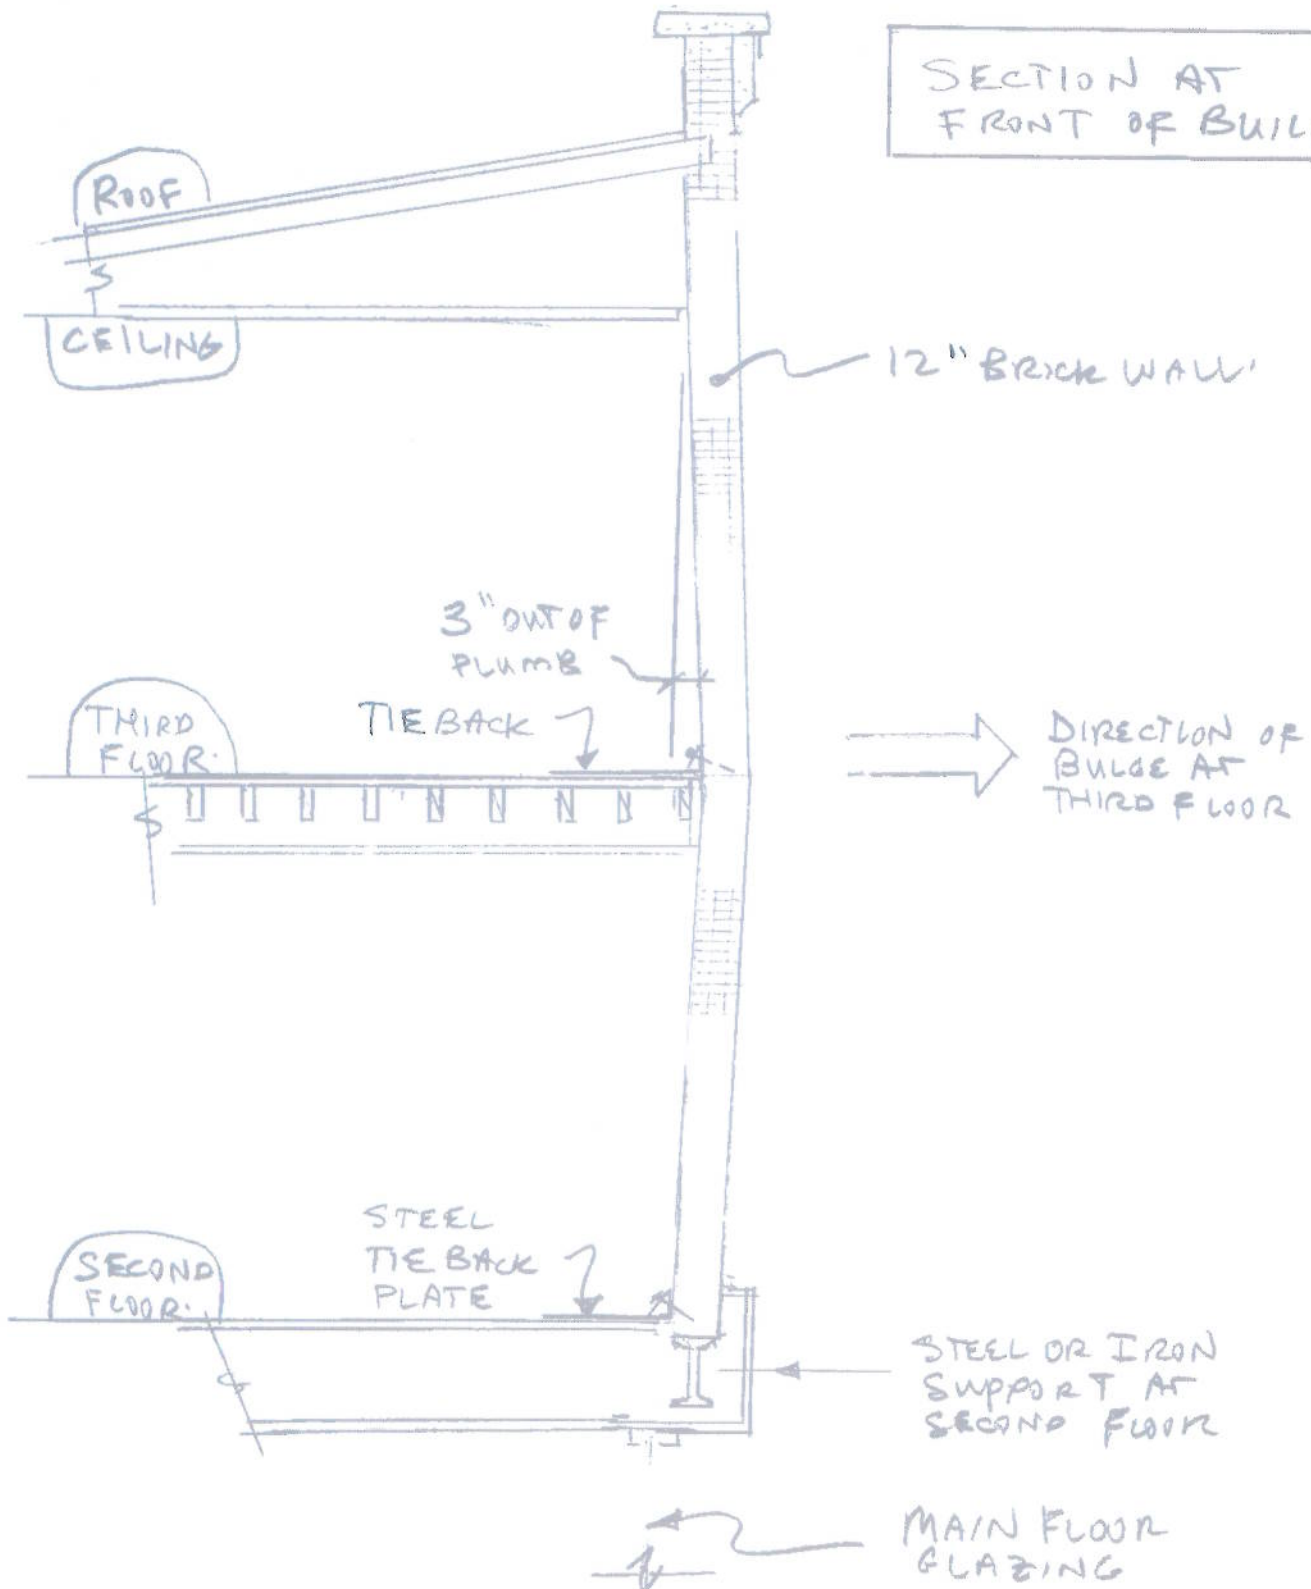
SK-1

The west wall was checked for plumb by measuring it at the Third Floor. The wall was found to be 3 inches out of plumb from the ceiling level to the floor (Sketch SK-1). As noted, the wall leans out to the west at the Third Floor level. This can be directly observed by the separation at the wall in the ceiling of the Second Floor (Photo 16).

SCHEMATIC SECTION

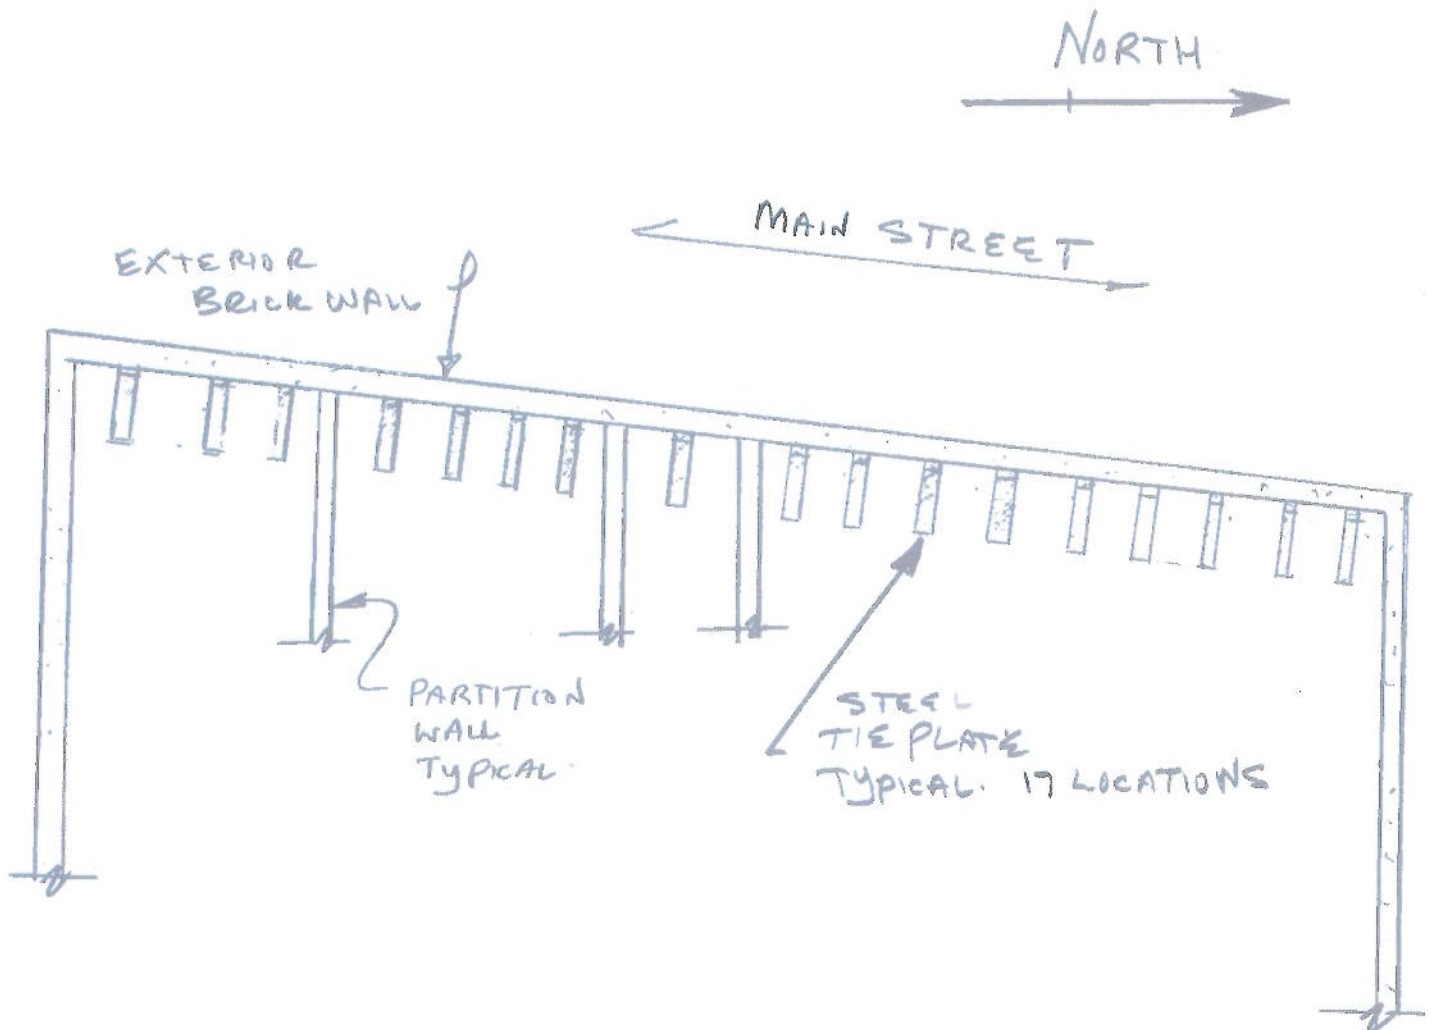
SK-2

There are 17 steel anchor plates tying the west wall into the floor structure at the Third Floor (Sketch SK-2). At the Second Floor the wall is anchored to the floor with 16 steel plates. The west wall is supported vertically at the Second Floor upon a steel or iron beam. The flange of the beam was observed in the gap between the floor and the wall. The Main Floor at the west elevation is essentially an open window wall. Columns which support the beams in the façade can be seen from the Main Street sidewalk.

PLAN - THIRD FLOOR TIE PLATES

LOCATION OF  
BULGE IN  
WALL AT  
THIRD FLOOR

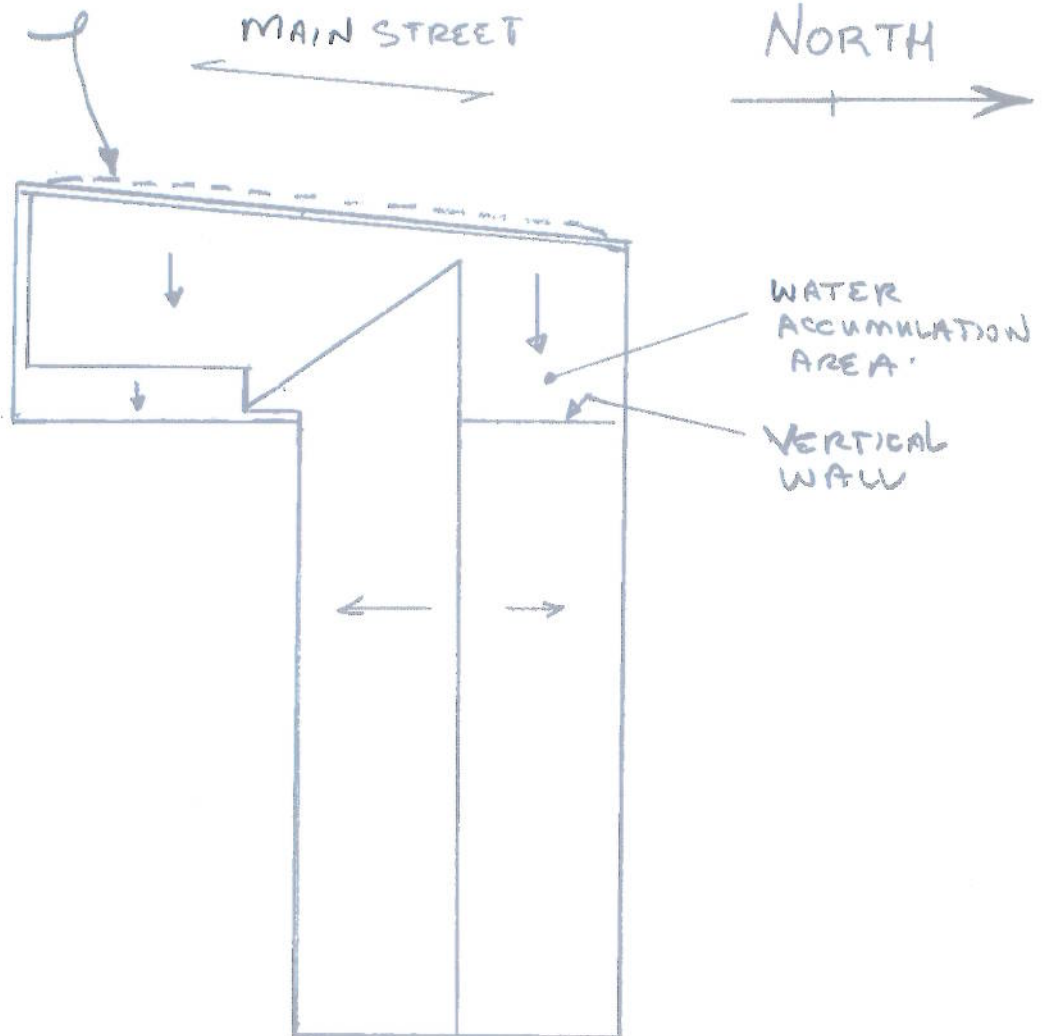
SK-3

There are leaks present in the roof of the building. At the level of the Third Floor a portion of the ceiling has collapsed in the northwest quadrant (Photo 21). The roof framing and the floor in this area was wet. The roof leaks will eventually lead to rotting of the wood in the roof and the floors below. The potential for local collapse and loss of bracing to the perimeter masonry walls exist should the rot in the wood become advanced.

ROOF PLAN - SCHEMATIC

2. There are roof leaks present in the northwest quadrant of the building. This is an area of sloped roof that will trap snow and rain. The leaks should be addressed to prevent decay of the roof and the floors below so that the structural integrity of the building is maintained. This area of the roof and the floors below provide the bracing for the West masonry wall.

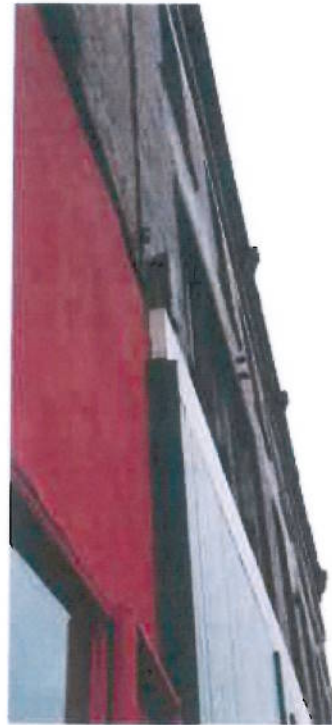
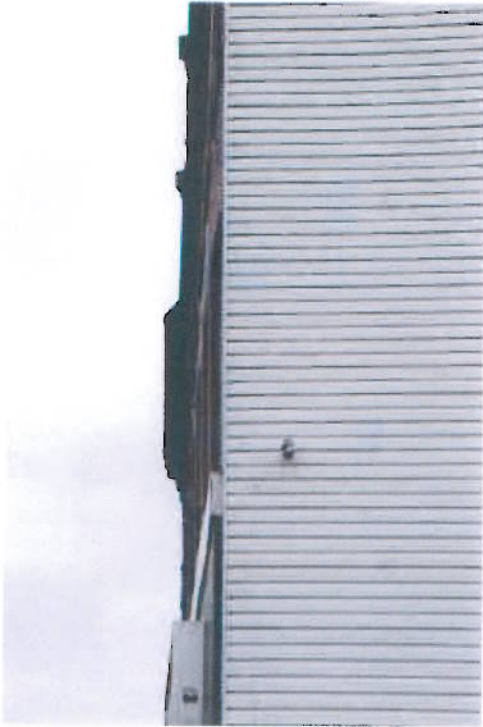
towards the street in the exterior brickwork (Photo 4 and Photo 5). The bulge is most pronounced at the Third Floor and extends for nearly the full width of the building. In 2002 approximately, steel straps and anchors were provided to tie the west façade back into the floor framing at the Second and Third Floors. We have reviewed the anchors during our site visit. We find that the anchor installation appears to be sound. The bolts connecting the anchors to the wall did not move when hand pressure was applied (Photo 18).

1. The greatest concern for public safety is the West wall on Main Street. The wall leans out toward the street. Steel plate connections tie the wall into the floor framing at the Second and Third Floors. The steel plate connections have been in place for approximately 12 years.

**Photo 4 – Bulge in West Wall at Level 3**

**Photo 5 – Bulge in West Wall at Level 3**

The West wall appears to be stable at present. However, the condition of the single bolt connection component inside of the brick wall is not known. We recommend that the connection capacity should be established by a load test. This test should be supervised by an engineer. The capacity of the connection requires evaluation to ensure that NBCC requirements are met. We further recommend that these steel plate connections be reviewed at six month intervals. Consideration can also be given to providing a more secure connection that would bolt through the wall and have bearing plates on the exterior face of the wall.

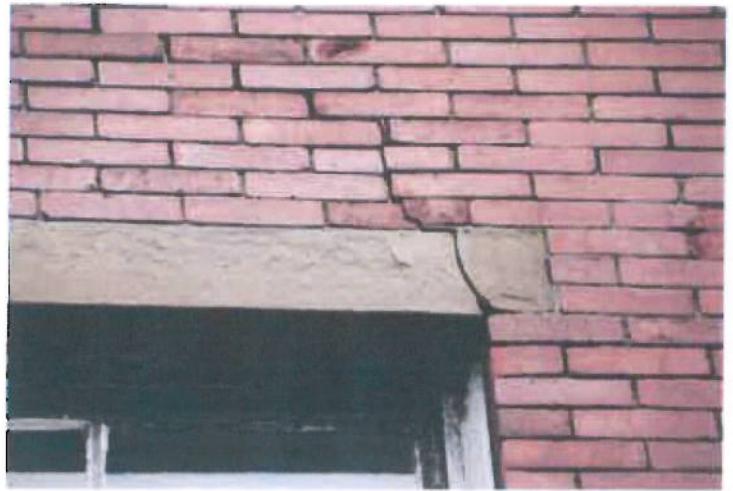
**Photo 6 – Break in Lintel – West Elevation**

3. Cracks were observed in the sandstone lintel at the south window of the Second Floor on the West elevation. Shoring should be added to support the lintel in the window opening until the lintel can be repaired or replaced.

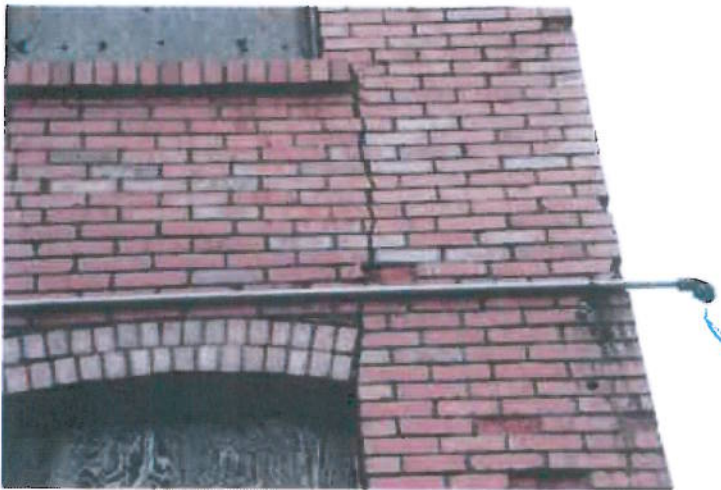
**Photo 7 – East Elevation – Cracks in Masonry**

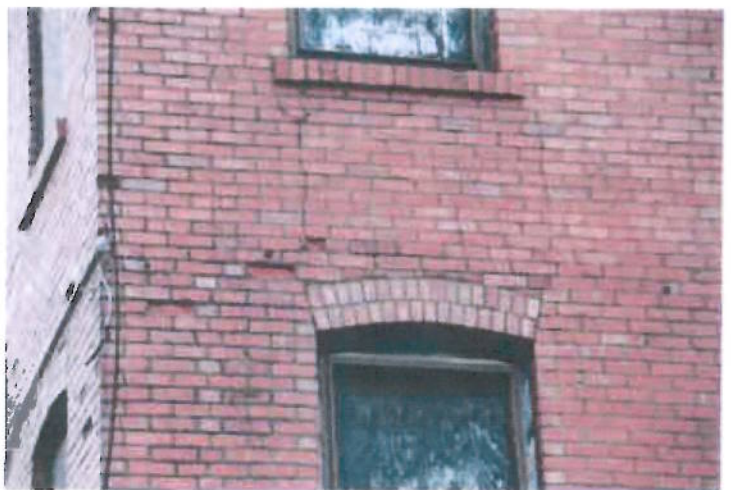
**Photo 8 – Masonry Cracks at Northeast Corner**

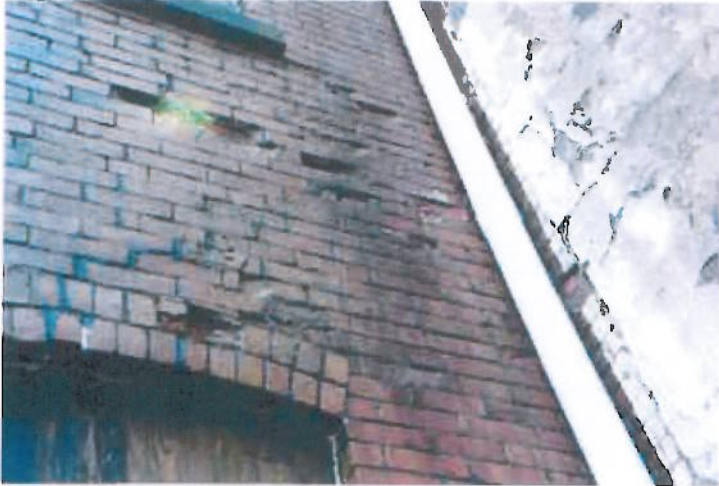
**Photo 9 – Deteriorated Brick at North Side  
in Area of Downspout**

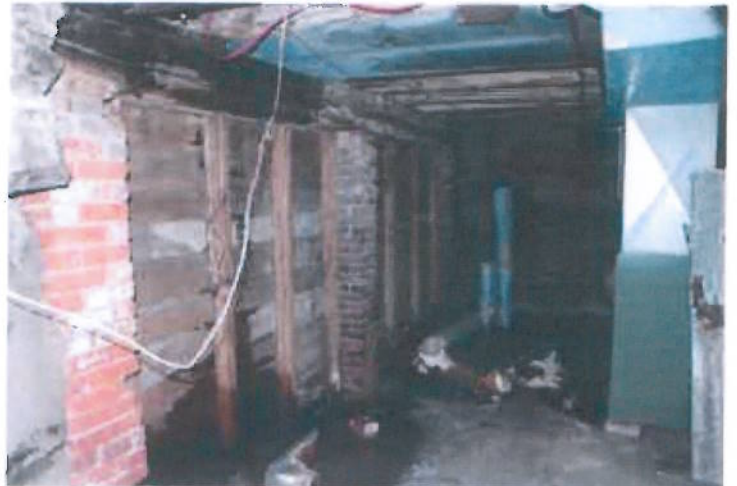
5. The basement area is wet. The high moisture levels and the mold that is now present will lead to the decay of the Main Floor framing. Persons entering the building should be made aware of this hazard and the potential for instability in the Main Floor.
6. There are locations on the exterior of the building masonry where cracks are present in the walls. These cracks should be monitored for additional movement which in the long term can lead to instability in the walls. Bracing should be added as required.
7. Leaks are present in the southeast quadrant of the building. The leaks can lead to decay of the floor framing and a potential safety hazard for people walking on the floor. Deterioration of the connection of the framing to the walls can lead to instability of the walls.

**Photo 10 – Wet Areas in Basement**

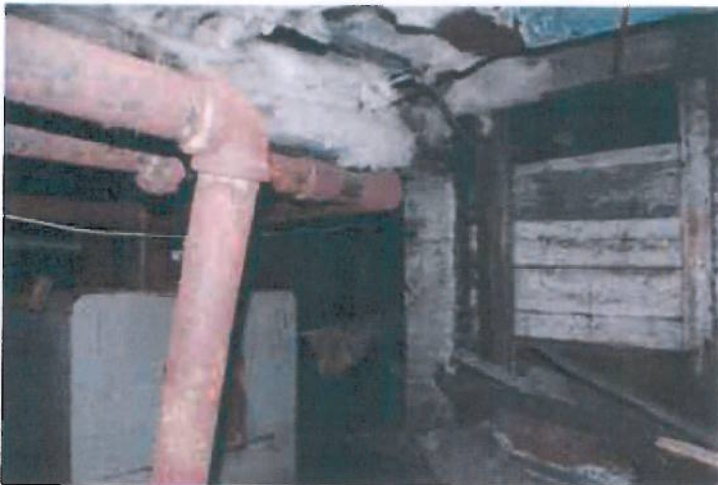
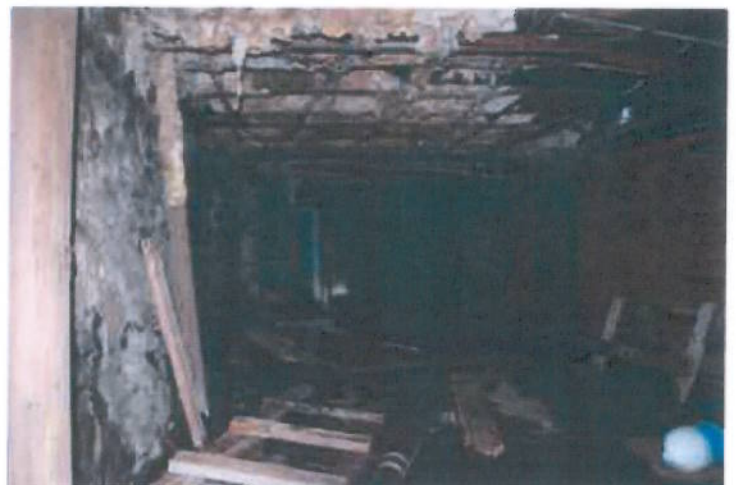
The basement area was accessed from the north side retail unit of the Main Floor. The area of the basement is very damp and some standing water was present on the floor. Large areas of mold could be observed between the floor joists on the south side of the basement (Photo 11 and Photo 12). This presents a high potential for rotting of the floor framing and also creates a potential safety hazard for people walking on the Main Level above this area.

**Photo 11 – Mold Growth at Underside of  
Main Floor**

**Photo 12 – Mold Growth at Underside of  
Main Floor**

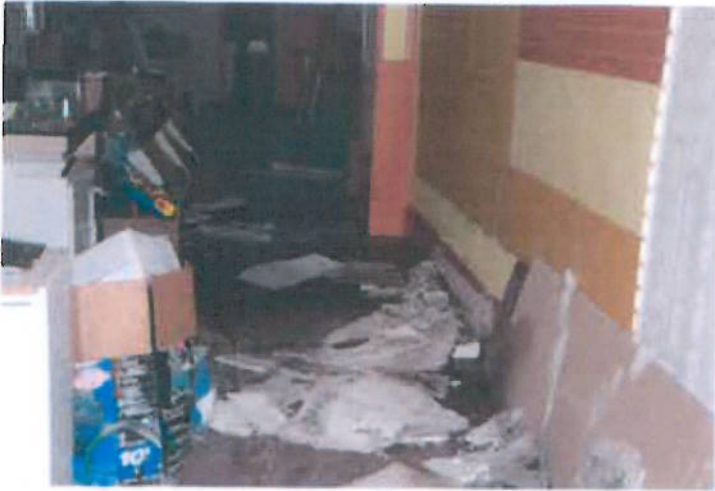
At the center of the Main Floor level, water leaks were observed coming from the area of a beam in the ceiling (Photo 13). The water leaks will lead to deterioration of the beam and could eventually cause a partial collapse of the floor structure.

**Photo 13 – Active Leak – View of Main Floor, North Half**

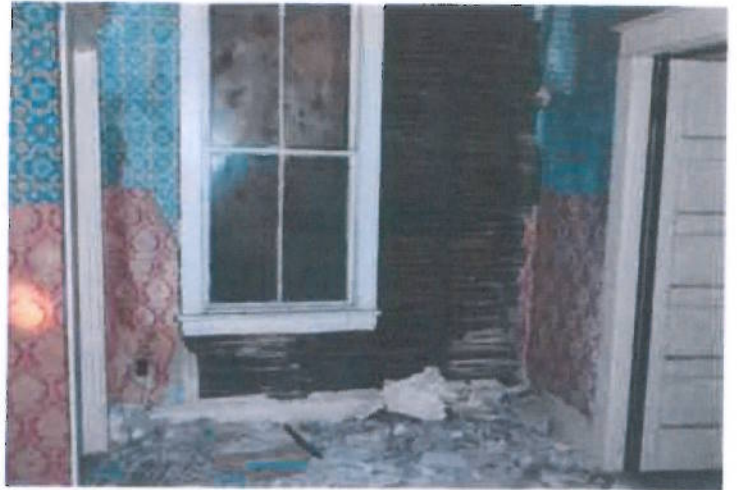
Within the east extension of the building, leaks were observed in the southeast quadrant of the building (Photo 14). These leaks were running down the exterior wall and could lead to rotting of

the ends of the floor joists where they bear in pockets in the masonry wall. Decay of the ends of the joists could lead to an instability in the masonry wall.

**Photo 14 – Active Leak in Southeast Quadrant**

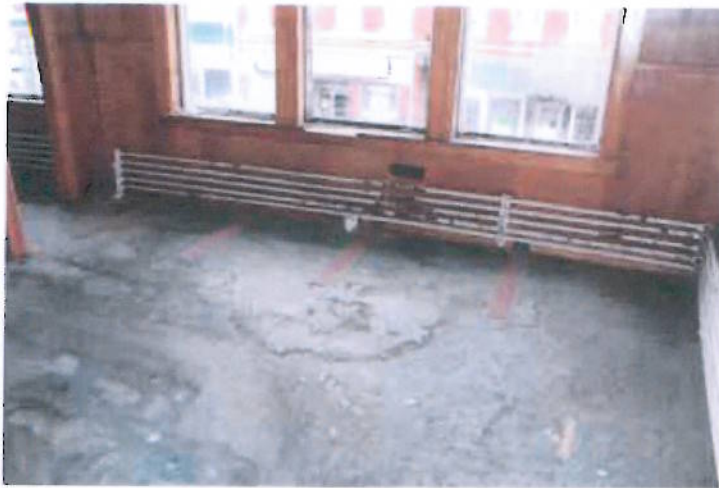
**Photo 15 – Steel Tie Straps at Second Floor**

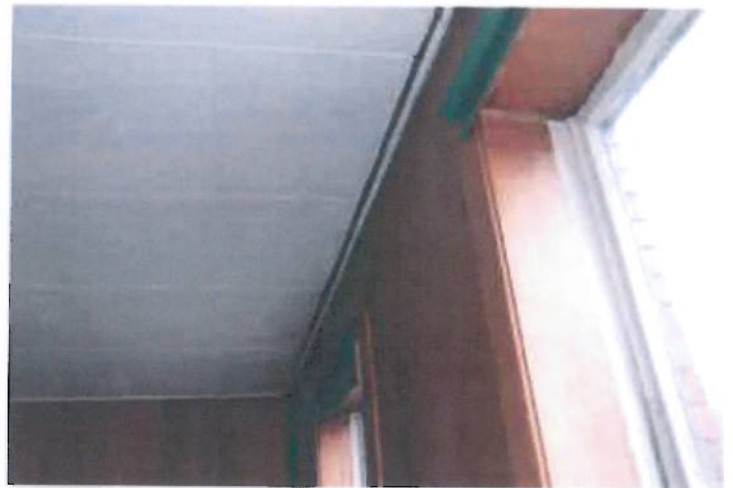
**Photo 16 – Separation at Ceiling of Second Floor**

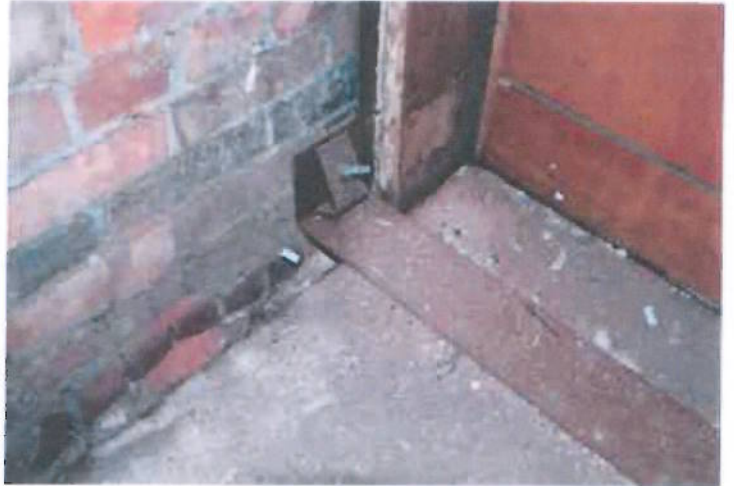
**Photo 18 – View of Anchor Bolt at West Wall**

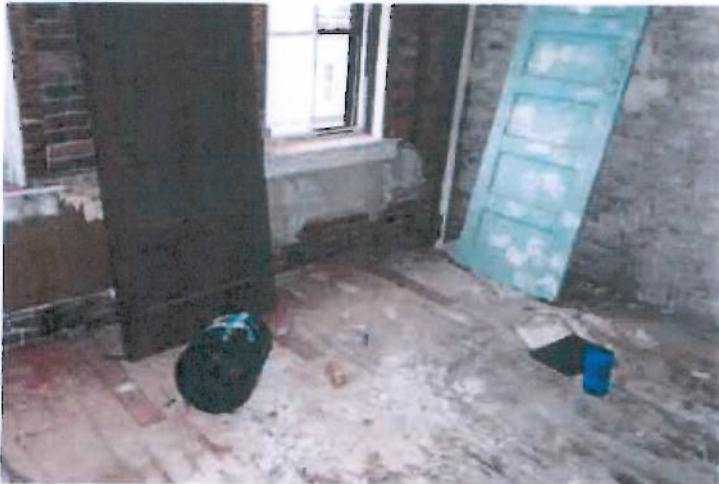
**Photo 19 – Steel Tie Straps at Third Floor**

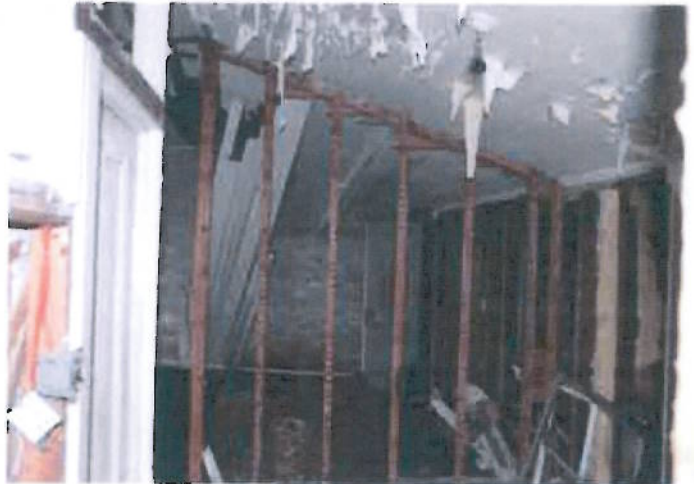
**Photo 20 – Photo Area of Leaks at Third Floor Ceiling**

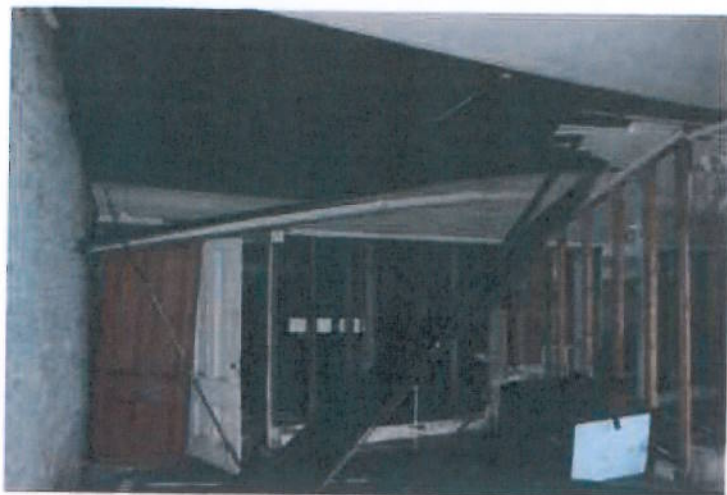
**Photo 21 – Area of Collapsed Ceiling and  
Roof Leaks at Third Floor**

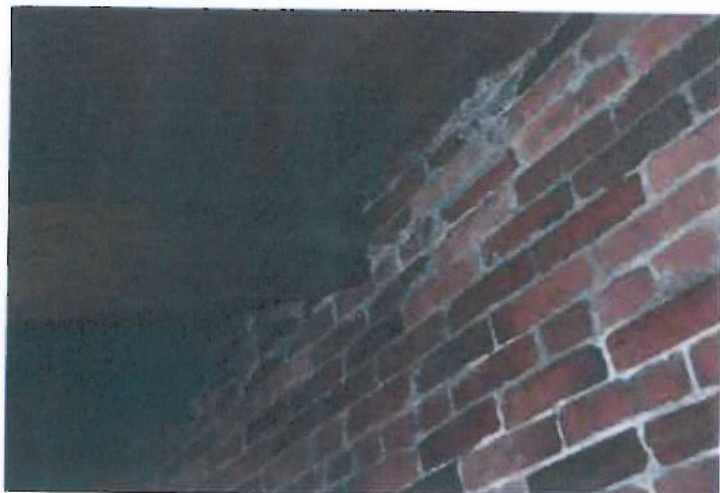
**Photo 22 – Roof joist Bearing at Top of West Wall**
