# **Pre-Demolition Investigation and Demolition Process of 305 Main Street**

**Prepared by: Nicholas Cottreau, EIT**

**2021-09-03**

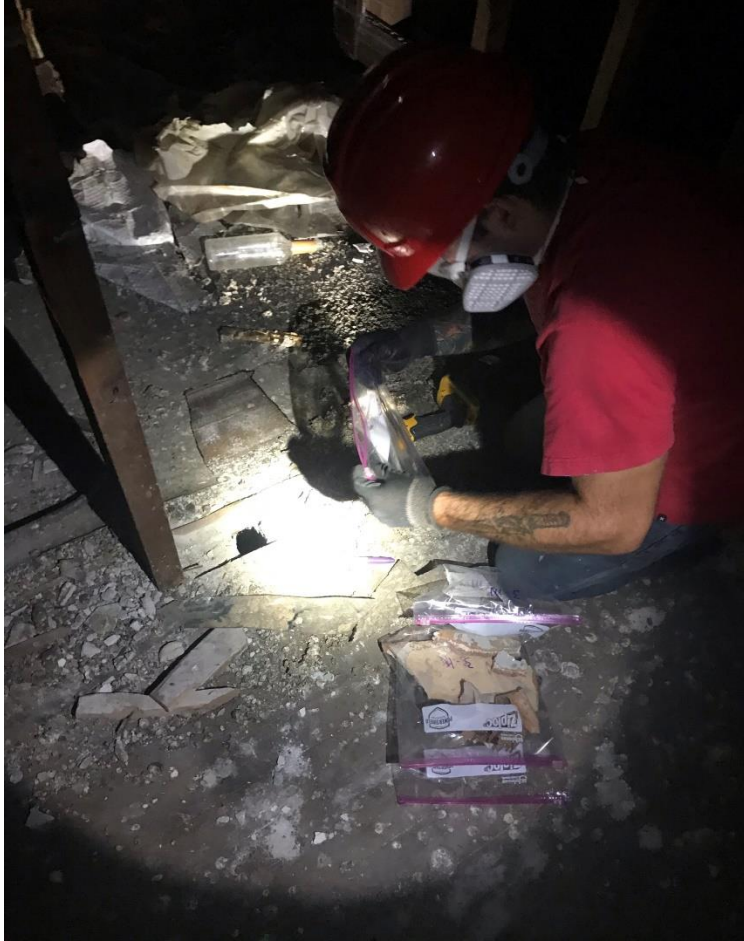
All samples were bagged in plastic zip-lock bags, packaged in cardboard boxes and sent for testing. Figure 1 shows sampling of materials on the third floor of the building.

Figure 1 – Sampling of materials

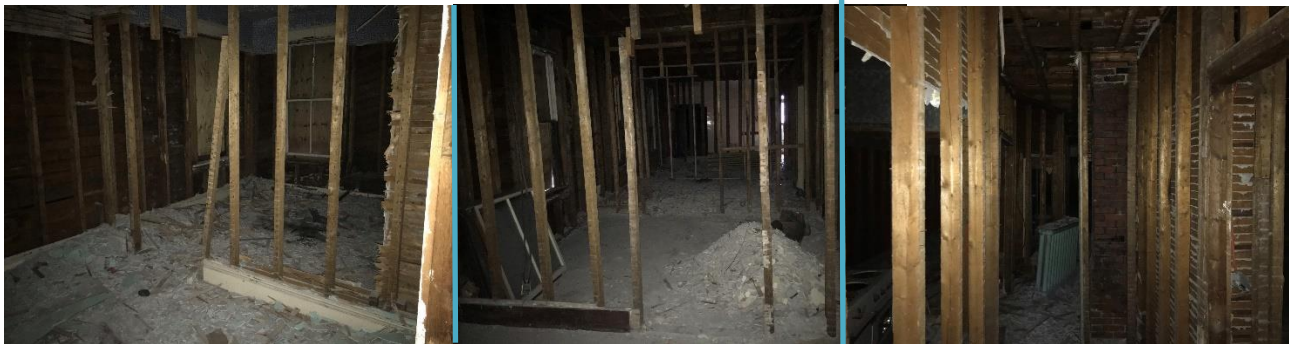
The interior of the building is littered with construction debris such as plaster, rotted wood, old boards, and insulation (see Figure 2). There is also a large amount of garbage scattered throughout the building, which seem to be from current and past occupancies (see Figure 3). This garbage varies from old furniture, personal items, waste from fast food and old appliances/fixtures. It is recommended that items of significance be collected, and the owner given a chance to reclaim some of the items.

Figure 2 - Construction Debris within building

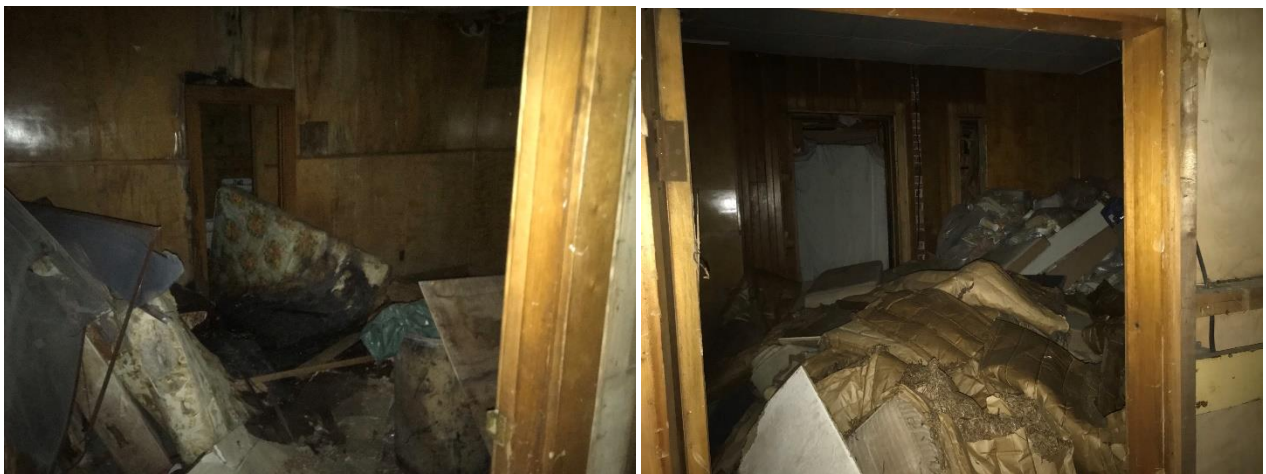
Figure 3 – Garbage within building

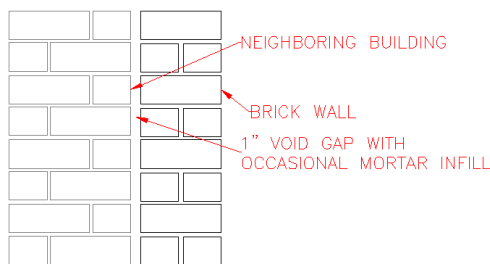
One of the main concerns which needed to be investigated prior to the demolition was the fact that the building in question was touching its neighbour to the north. 3 test holes were made in the north wall of the building, one on each floor, to investigate the interface between the 2 buildings. On all 3 floors, the north wall contained 2 courses of brick, followed by a 1" void between both buildings. This void was occasionally filled with mortar that seeped in, as well as accumulated debris from the roof over time. There is no evidence of any brick ties or other means of fastening both buildings together. On the Main Street side, the seam between buildings is filled with a caulking compound. Figure 4 shows a cross section of the wall interface. Figure 5 shows the investigation of the wall interface. Left is the crew punching through the wall, center is a closeup of the investigation hole and right is looking inside the void between both walls. These photos were taken at the third storey. No mortar or debris was present at this hole.

Figure 4 – Typical wall interface

Although there is no evidence that both buildings are tied together in any way, it is recommended that both buildings be completely separated at the roofline by hand prior to major demolition. It is also recommended that the chimney be removed by hand for the top 10 feet, to ensure that the chimney is not tied from the inside to the neighbouring building. The exact demolition plan will be coordinated at a later date with the successful demolition bidder.

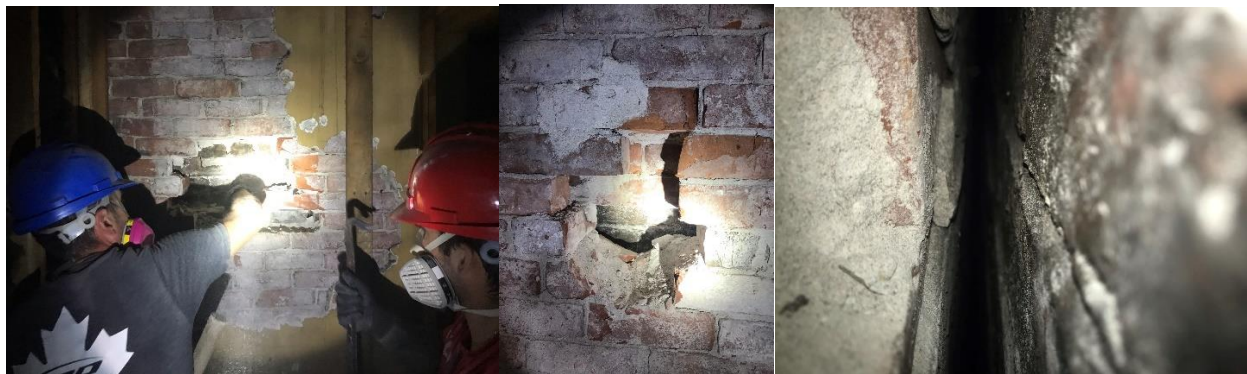
Figure 5 – Investigation of the wall interface

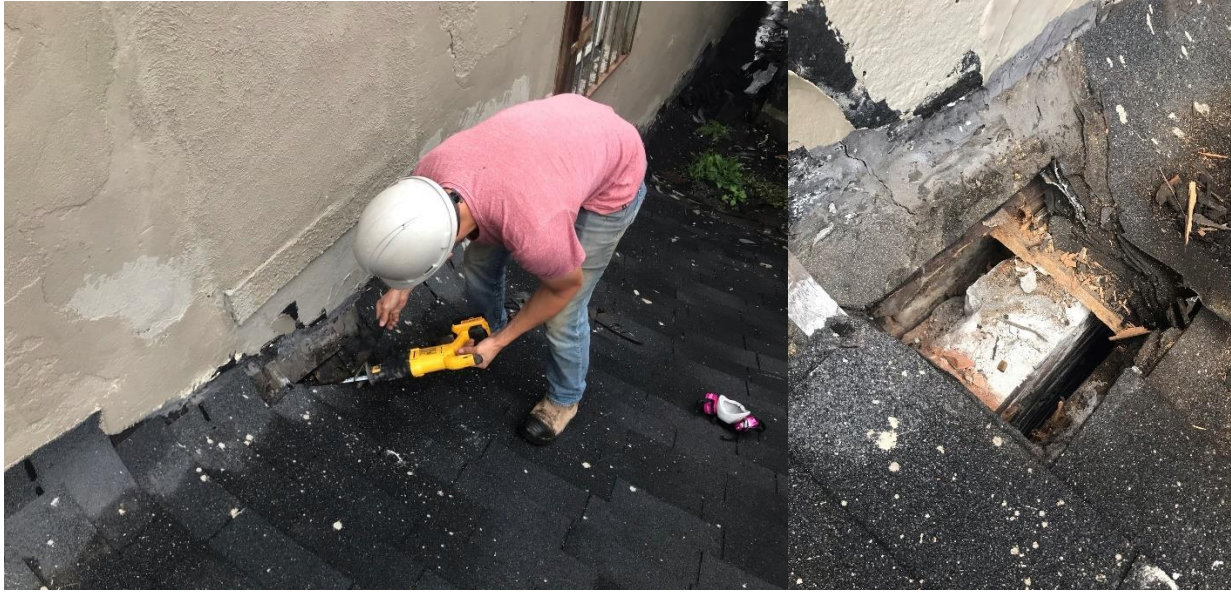
The roof of the building in question also butts up against the neighbouring building to the north. It is heavily flashed with shingles, metal flashings and approximately 3" of tar. The tar and flashings are applied directly to the wall of the neighbouring building (see Figure 6). There is also a rafter between the brick wall and the neighbouring building, which catches the edge of the roof. This rafter is nailed directly to the neighbouring building (see Figure 7). Figure 8 shows a cross section of the roof interface between both buildings. There is also a chimney protruding through the roof, which belongs to the building at 305 Main. Metal bars which protect the neighbouring building's windows have been installed, with one fastened to the chimney. While the chimney appears to be completely independent of the neighbouring building, the window guard will need to be removed prior to demolition. Figure 9 shows the chimney protrusion through the roof of 305, as well as the protective grating for the neighbouring building which is fastened to the chimney.

Figure 6 – Investigating the roof interface

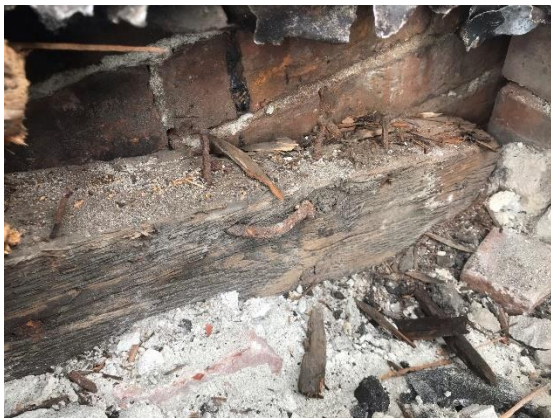
Figure 7 – Rafter nailed to neighbouring building

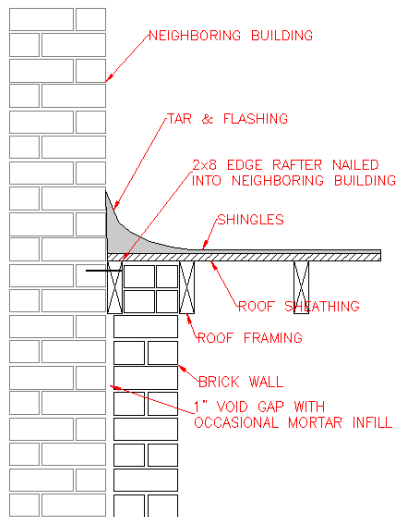
Figure 8 – Cross section of roof interface

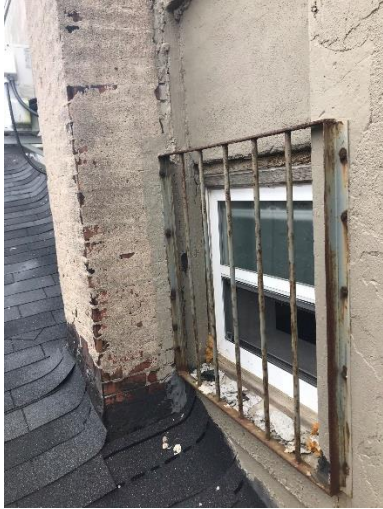
Figure 9 – Chimney protrusion

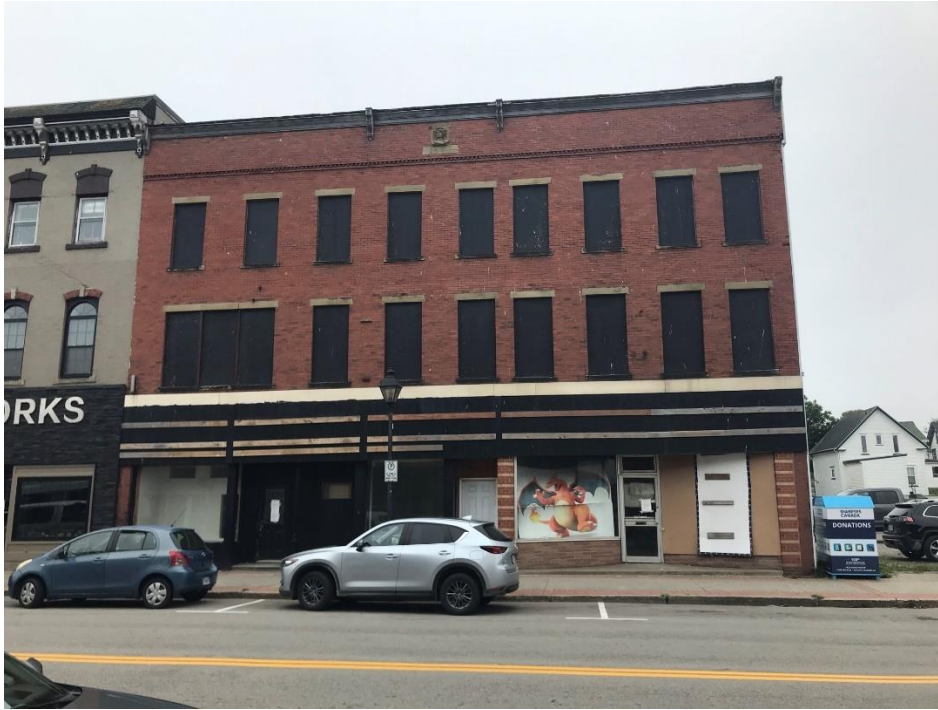
Figure 10 shows the western elevation of the building, taken from the opposite side of Main Street. As seen, space is limited. The building butts up directly against its neighbour to the north, and a reserved gravel parking area lies to the south. Figure 11 shows the southern elevation of the building. The portion clad with vinyl siding is the section of the building that was temporarily shored by Delmar Construction in spring of 2021. Access to this section is restricted. A small gravel parking area belonging to the property is also shown in this photo (where the Delmar pickup is parked). This space is the only space that is owned by the building. The larger gravel parking area in the foreground is reserved parking for neighbouring apartment buildings, but can be vacated during the demolition and used as a work area. Figure 12 shows the eastern elevation of the building. The grey building is Ice Works to the north. The 2 buildings are touching for the full length of the Ice Works building. There is a gap between the east wing and Ice Works at the roof level, which serves as a drain trough for the roofs from the front portion of the building. Figure 13 shows the alleyway on the eastern side of the building. The distance from the building to the apartment unit to the east is approximately 24'8".

Figure 10 – West Elevation

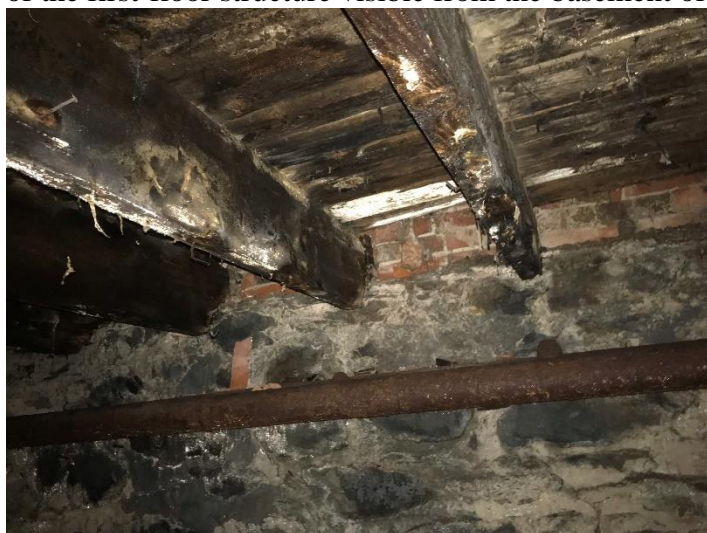
While investigating the basement, the first-floor joists and floorboards were noted to have severe rot. These floor joists were bearing on the stone foundation, both of which were extremely wet due to water infiltration from above and dampness in the basement. This rot issue carried up to the second level floor joists. These joists were rotted to a point where the second floor was unstable. Both locations were noted to be directly below the trough at the back of the roof between both buildings. While debris generally prevents access to these areas of the building, it is strongly discouraged that anyone should access these portions of the building. Figure 14 shows the decay of the first-floor structure visible from the basement of the building.

Figure 14 – Structural decay in the basement

Any contractors who would like to visit the building should not enter without one of Delmar's employees present. Guidance through the building is required to avoid the unsafe areas.
