RE: 301-309 MAIN ST., YARMOUTH, NS.

***STRUCTURAL REVIEW  
305 MAIN STREET  
YARMOUTH, NS***

***MARCH, 2015  
11815***

RE: ***305 Main Street / Structural Review  
Yarmouth, NS***

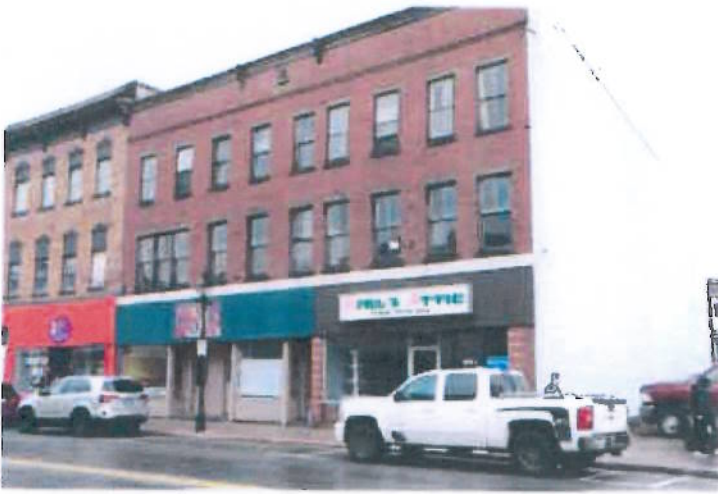
**Photo 1 – West Elevation (Main Street)**

On January 19, 2015 a site visit was carried out by the writer at 305 Main Street in Yarmouth, Nova Scotia (Photo 1). The purpose of the visit was to view the structure of this building and to prepare a report regarding any observed unsafe conditions and deficiencies in the building structure. The building complex is presently unoccupied. I was accompanied by you and by Ms. Lorelei Atkinson, Town of Yarmouth Building Official, for the site visit.

During the site visit we were able to observe the exterior and the interior of the building. At locations where the building finishes have been removed, as well as in the basement, the structure of the building can be observed. The west elevation of the building on Main Street displays a bulge
