# **Pre-Demolition Investigation and Demolition Process of 305 Main Street**

**Prepared by: Nicholas Cottreau, EIT**

**2021-09-03**

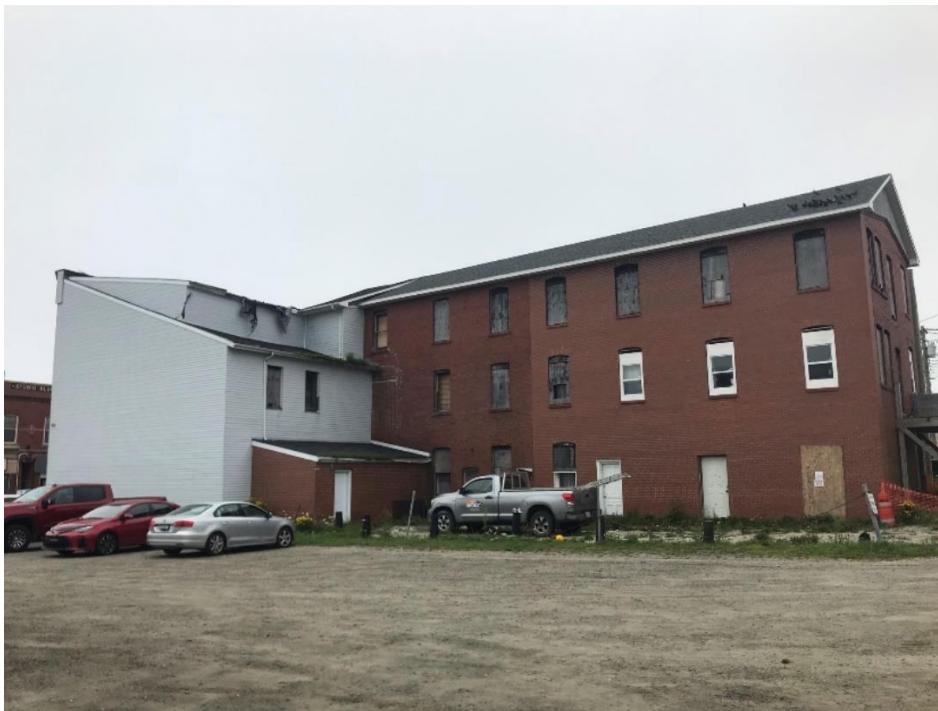
Figure 10 – West Elevation

Figure 10 shows the western elevation of the building, taken from the opposite side of Main Street. As seen, space is limited. The building butts up directly against its neighbour to the north, and a reserved gravel parking area lies to the south. Figure 11 shows the southern elevation of the building. The portion clad with vinyl siding is the section of the building that was temporarily shored by Delmar Construction in spring of 2021. Access to this section is restricted. A small gravel parking area belonging to the property is also shown in this photo (where the Delmar pickup is parked). This space is the only space that is owned by the building. The larger gravel parking area in the foreground is reserved parking for neighbouring apartment buildings, but can be vacated during the demolition and used as a work area. Figure 12 shows the eastern elevation of the building. The grey building is Ice Works to the north. The 2 buildings are touching for the full length of the Ice Works building. There is a gap between the east wing and Ice Works at the roof level, which serves as a drain trough for the roofs from the front portion of the building. Figure 13 shows the alleyway on the eastern side of the building. The distance from the building to the apartment unit to the east is approximately 24'8".
